Technical Bulletin

Bulletin No	VAC	2013-01	Issued: 03/06/13	Revised: 03/18/13	Page 1 of 1
Equipment	Case Packers				
Topic	Loss of Carton-Pulling Vacuum

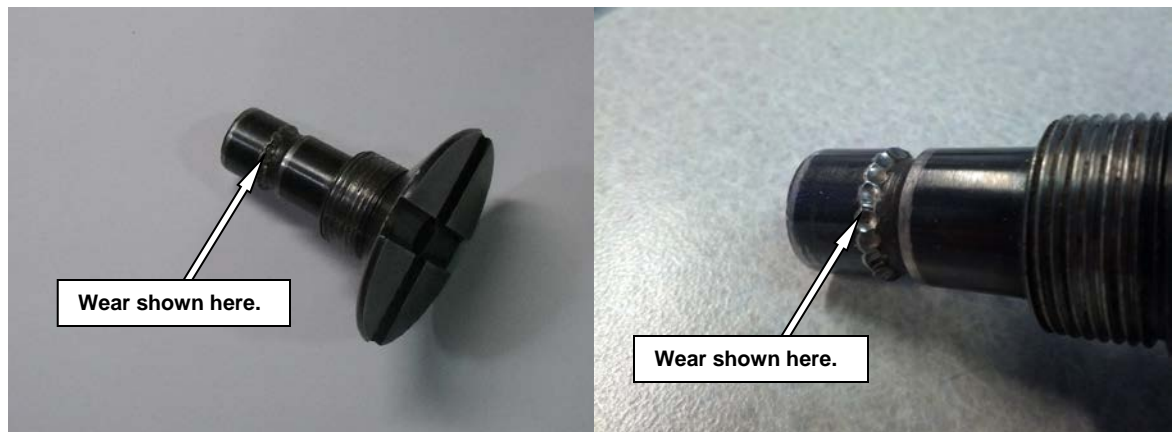
Loss of vacuum pull at the suction cups can be caused by extreme wear to the rigid sucker nipple. This can prevent the quick-disconnect's auto-close feature from disengaging when the rigid sucker is inserted, and keep the disconnect sealed closed.

The wear will appear as bearing-ball shaped gouges or groove marks in the rigid sucker's nipple end, at the edge of the radial groove. **(See Picture Below.)**

2. Replace the rigid sucker nipple(s). **(Large # 250685, Medium # 320027, Small # 320028)**
